# Case Study

“Water Damage Grundschule Rülzheim”

# The Project

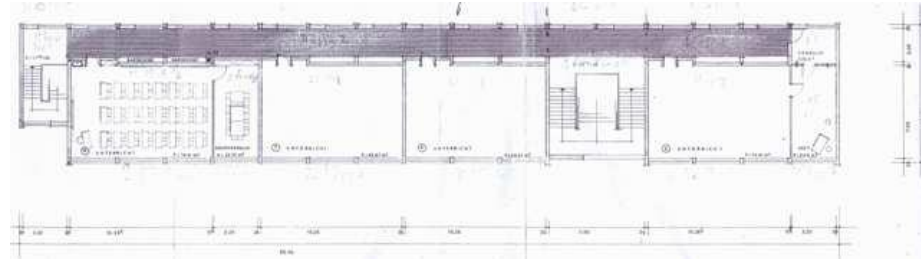
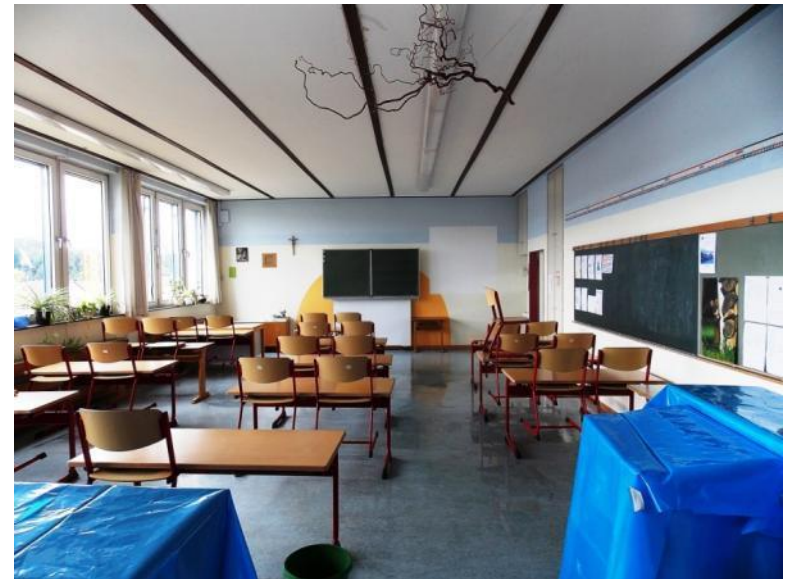
- 1950's Grundschule (Elementary School)
- Weather related loss
  - Tornado took the complete roof structure off at 21:30 on June 20<sup>th</sup> 2013.
  - Caused large amounts of water to enter into the 3<sup>rd</sup> floor of the school
  - Temporary roof was installed and finished on July 12<sup>th</sup> 2013
  - Water continued to enter the structure causing more damage to the 3<sup>rd</sup> floor and into the 2<sup>nd</sup> floor areas until the roof was temporary repaired
- Client is the city of Rülzheim and was managed by a local Architect

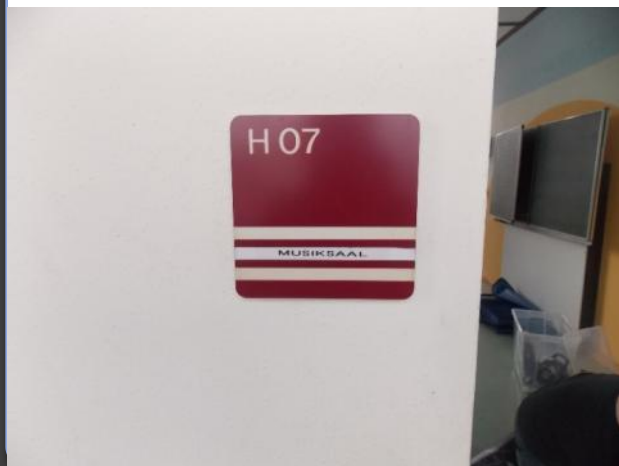
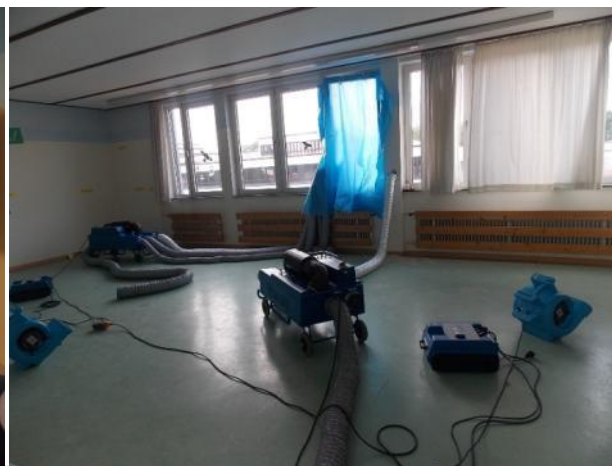
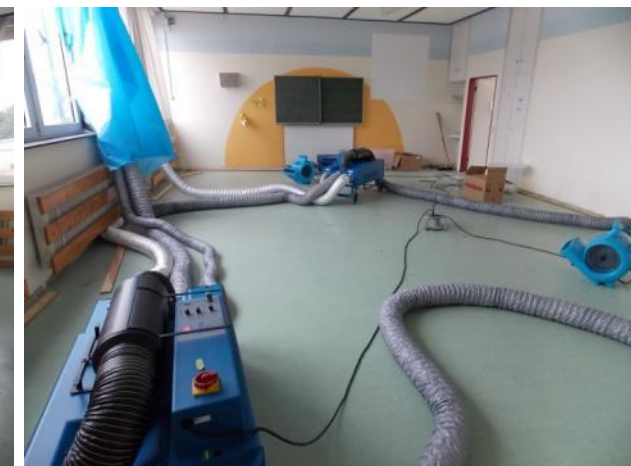
# The Project – 2<sup>nd</sup> Floor Classroom

- Consisted of a large classroom with drywall ceilings
- Ceilings were not removed prior to starting the drying process and were wet in places
- 2 Drymatic's, 2 boost boxes and 2 air movers were used for the total drying process of these areas

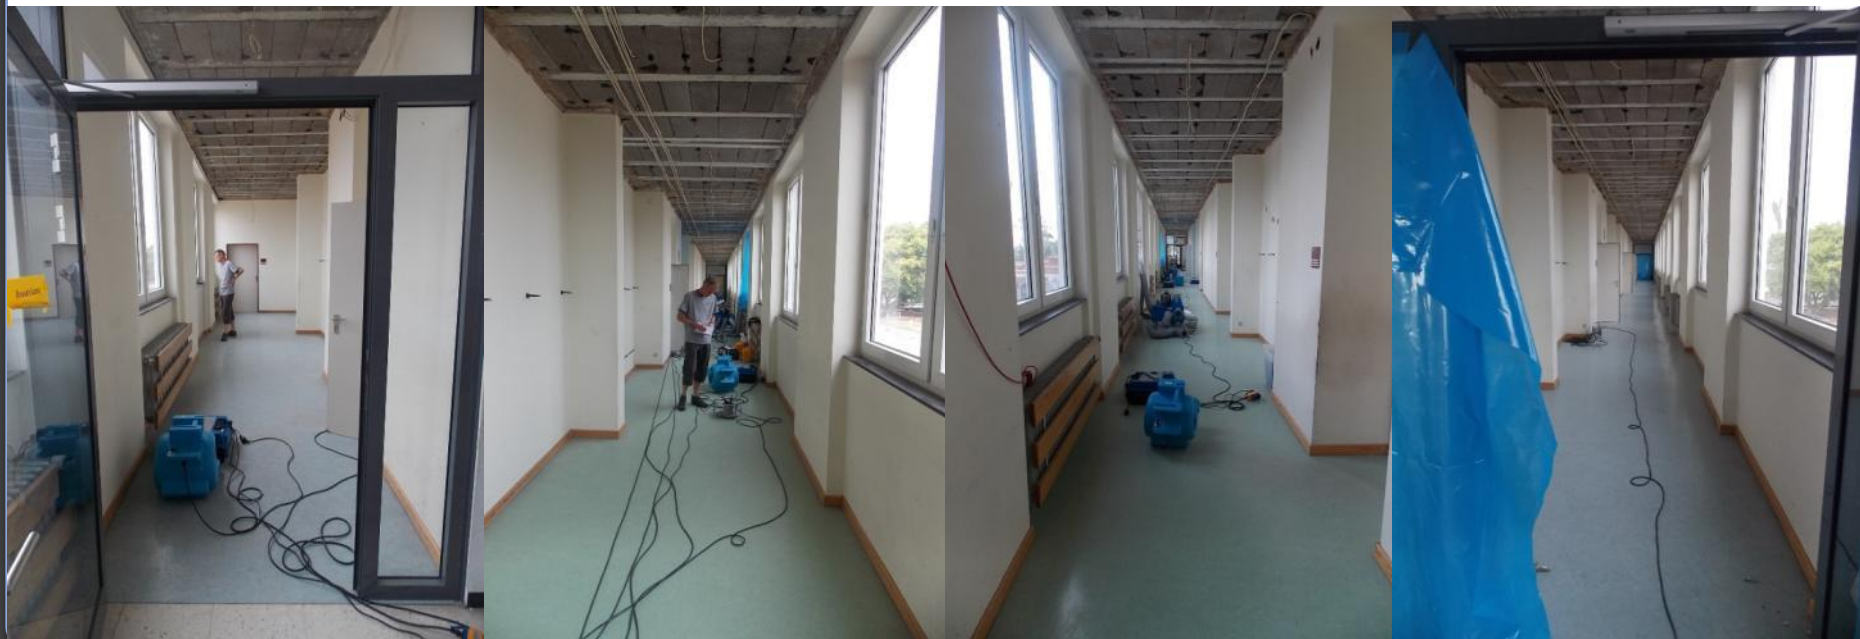
# The Project – 2<sup>nd</sup> Floor Hallways

- Consisted of a long hallway and a short hallway with high ceilings
- Ceilings were removed prior to starting the drying process
- 2 Drymatic's, 2 boost boxes and 3 air movers were used for the total drying process of these areas

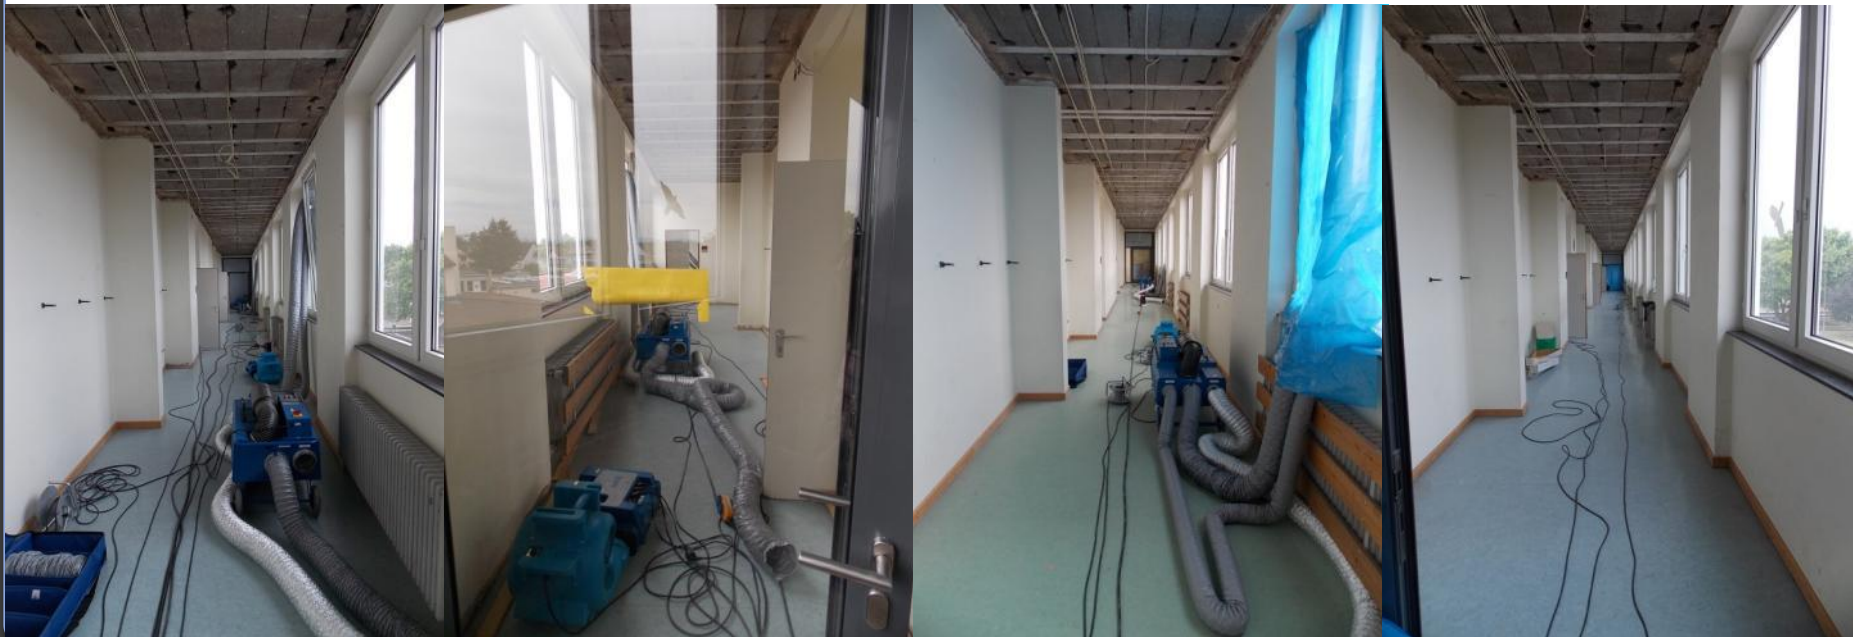
# The Project – 3rd Floor Hallways

- Consisted of a long hallway and a short hallway with high ceilings
- Ceilings were removed prior to starting the drying process
- 3 Drymatic's, 4 boost boxes and 6 air movers were used for the total drying process of these areas

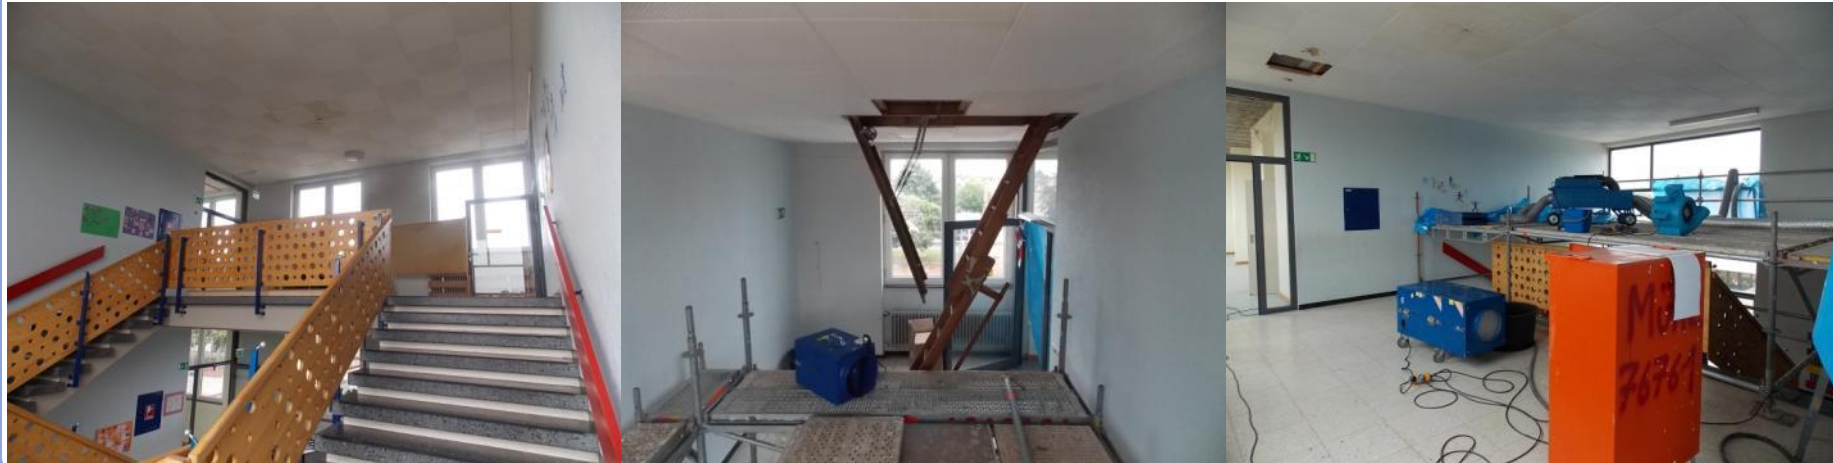
# The Project – 3rd Floor Stairwells

- Included one large stairwell with a lower landing area and one small stairwell with acoustic ceiling tiles and insulation
- 2 Drymatic's, 2 boost boxes, 2 air movers, 1 large and 1 small HEPA air scrubbing machine were used for the total drying process of these areas

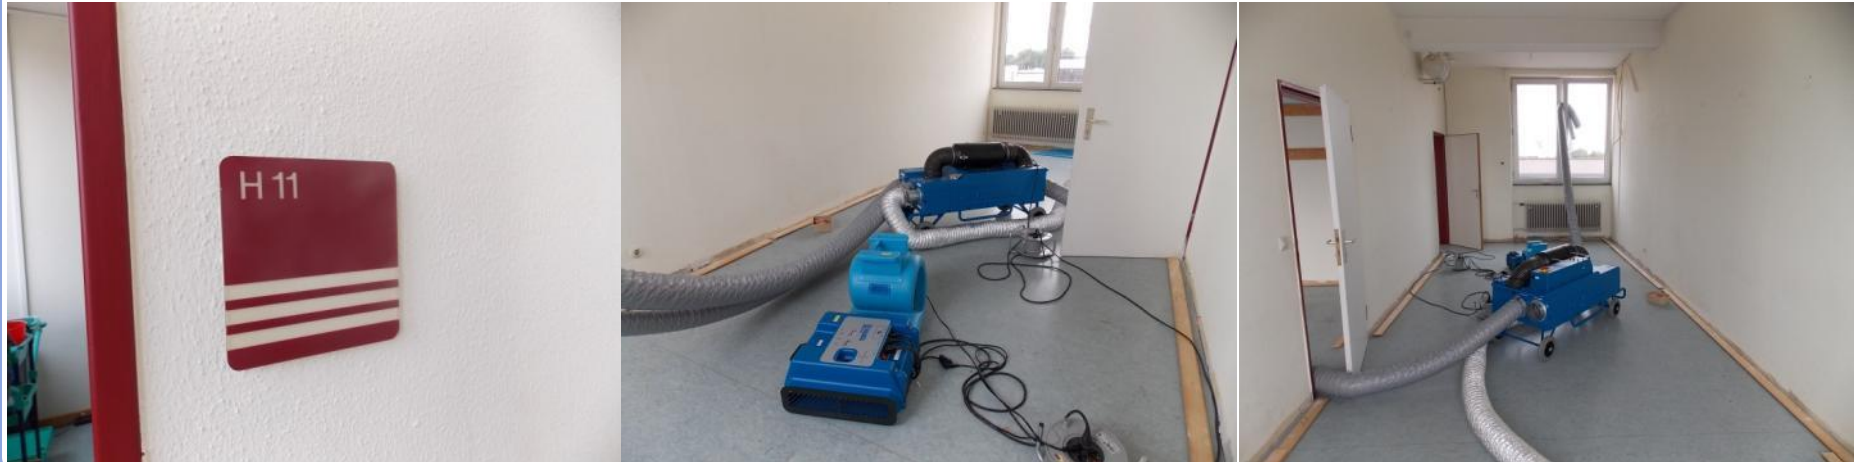
# The Project – 3rd Floor Classroom

- Consisted of a large classroom with drywall ceilings
- Ceilings were not removed prior to starting the drying process and were wet in places
- 1 Drymatic's, 1 boost boxes and 1 air movers were used for the total drying process of these areas

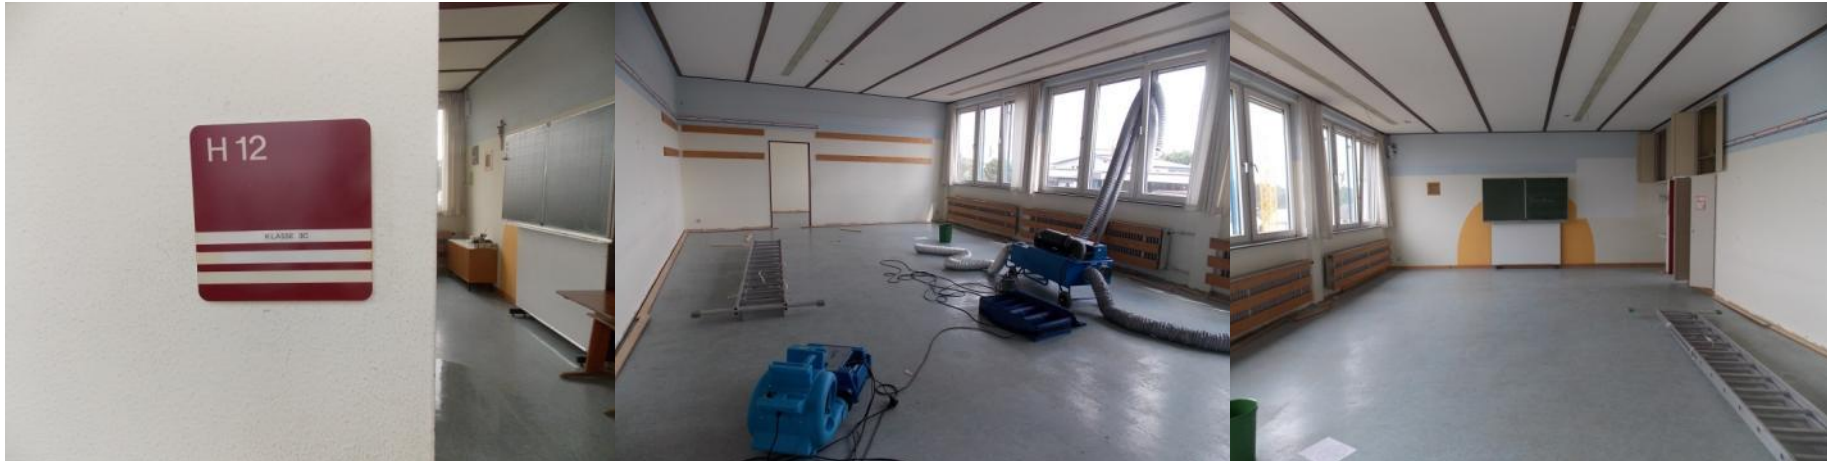
# The Project – 3rd Floor Classroom

- Consisted of a large classroom with drywall ceilings
- Ceilings were not removed prior to starting the drying process and were wet in places
- 1 Drymatic, 1 boost box and 1 air mover were used for the total drying process of these areas

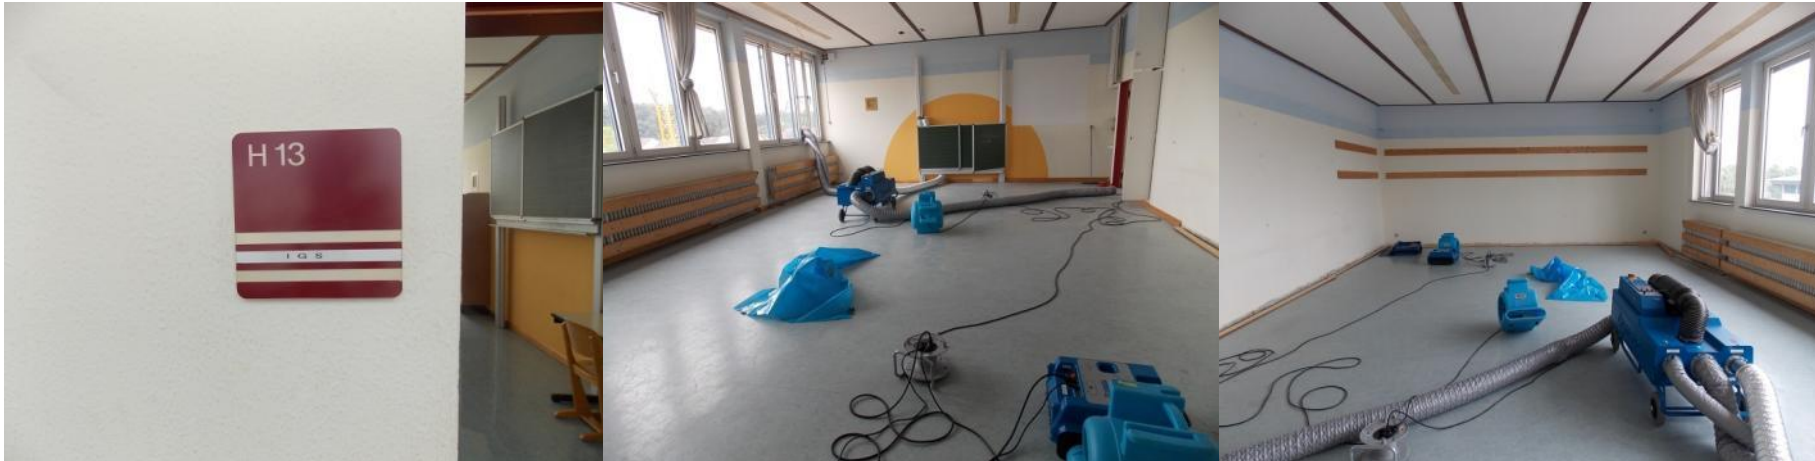
# The Project – 3rd Floor Classroom

- Consisted of a large classroom with drywall ceilings
- Ceilings were not removed prior to starting the drying process and were wet in places
- 1 Drymatic, 1 boost box and 1 air mover were used for the total drying process of these areas

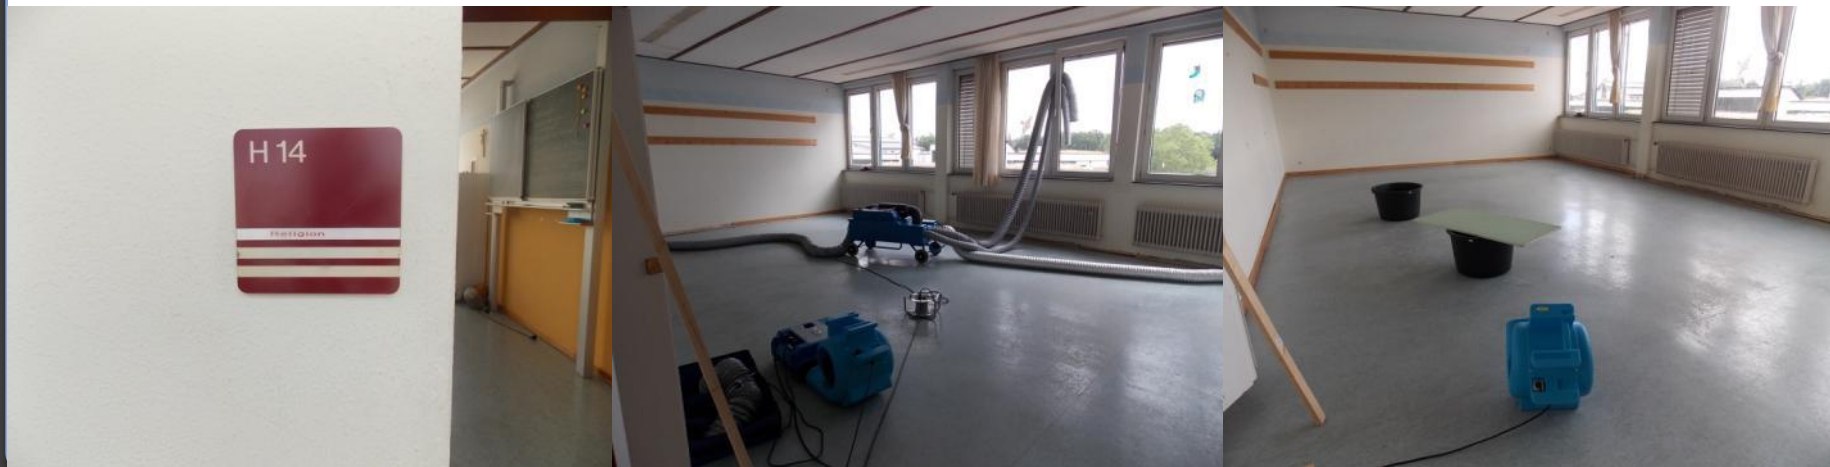
# The Project – 3rd Floor Classroom

- Consisted of a large classroom with drywall ceilings
- Ceilings were not removed prior to starting the drying process and were wet in places
- 1 Drymatic, 1 boost box and 1 air mover were used for the total drying process of these areas

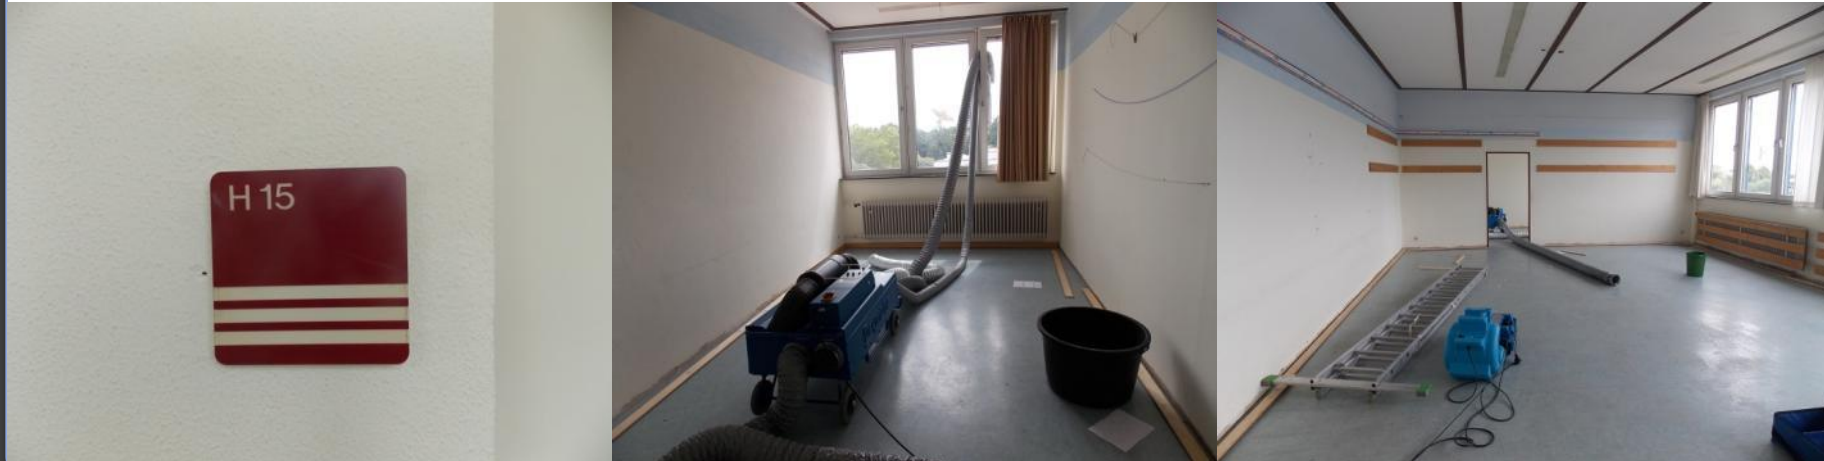
# The Project – 3rd Floor Classroom

- Consisted of a large classroom with drywall ceilings
- Ceilings were not removed prior to starting the drying process and were wet in places
- 1 Drymatic, 1 boost box and 1 air mover were used for the total drying process of these areas

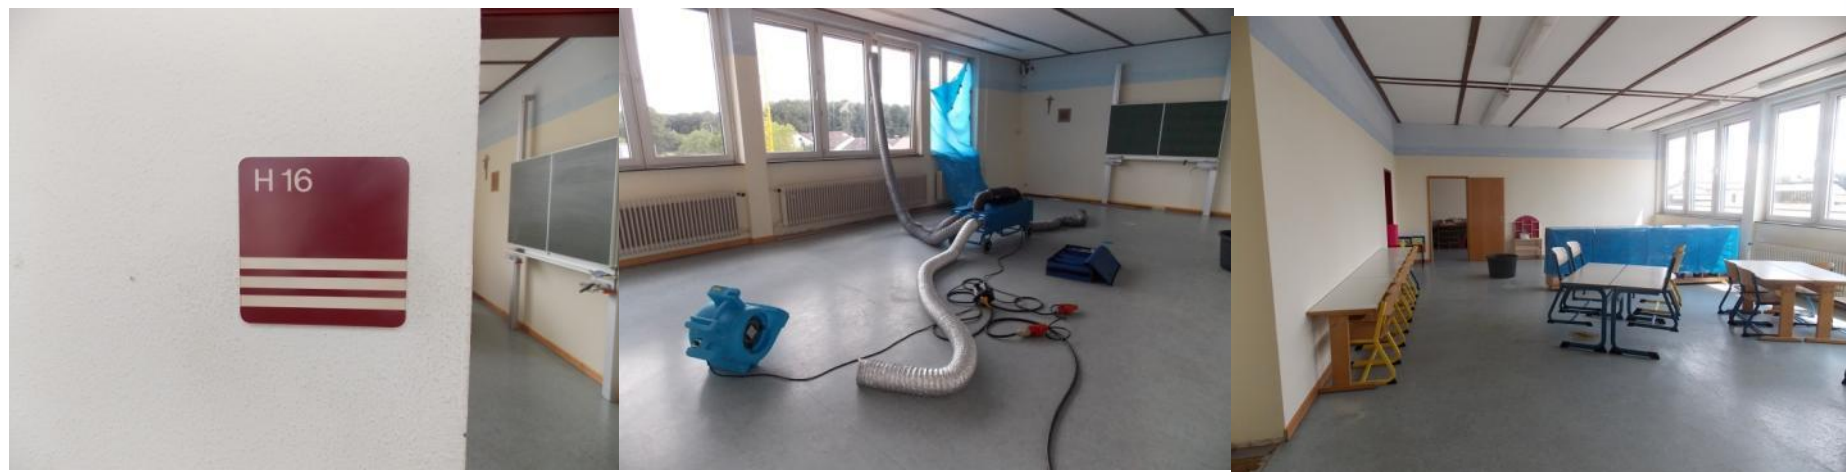
# The Project – 3rd Floor Classroom

- Consisted of a large classroom with drywall ceilings
- Ceilings were not removed prior to starting the drying process and were wet in places
- 1 Drymatic, 1 boost box and 1 air mover were used for the total drying process of these areas
