Case Study

“Water Damage SERR ROLF SR Metallbau
Rülzheim”

The Project

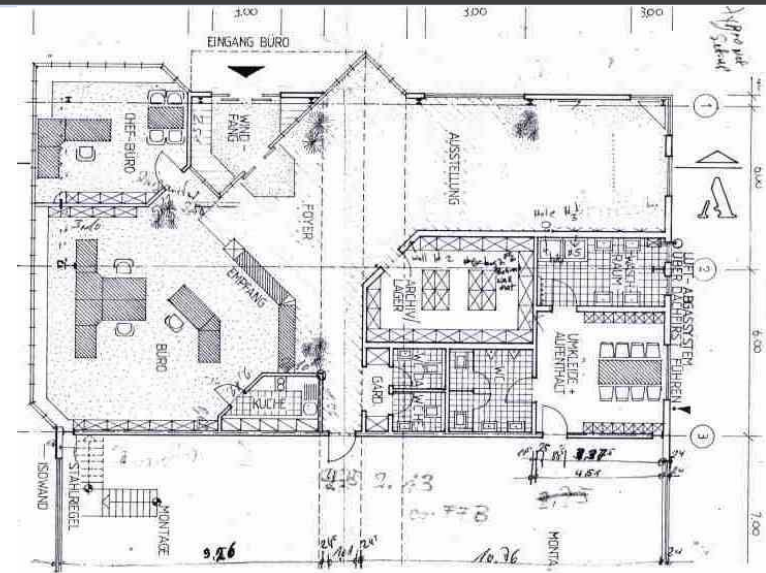
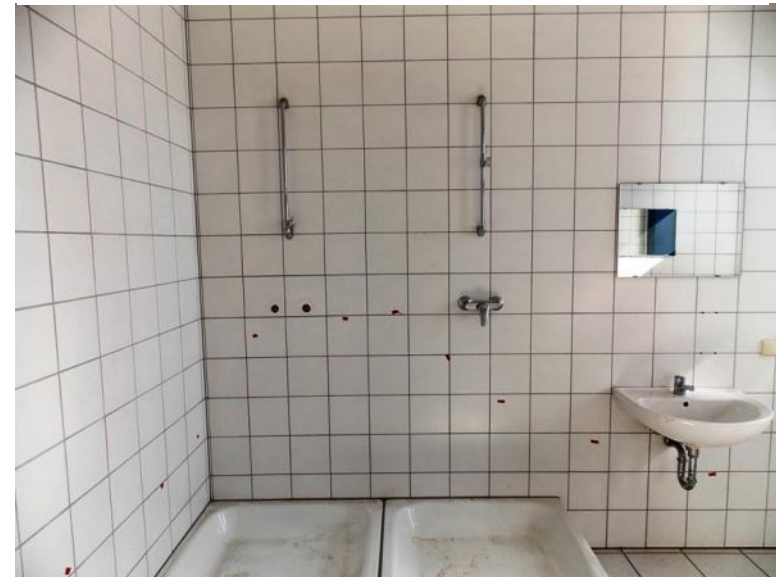
- 1980's German Commercial Building
 - Block walls
 - Layered floor over concrete
 - Plaster, wallpaper and paint on walls
 - Tile on walls and some floors
- Pipe leak in wall
 - Leak started at shower fauset and was not noticed for 6-8 weeks
 - Caused large amounts of water to leak into the walls and floor areas
 - All plumbing was redone in the building
 - Water was able to spread through the block wall construction and affect the other areas continued to enter the structure causing more damage to the other areas

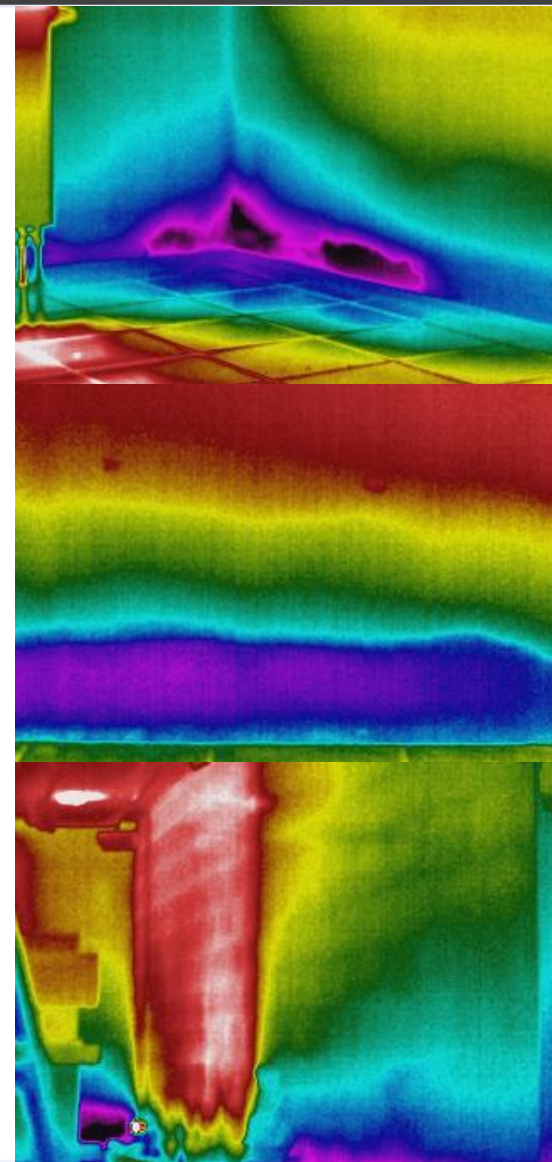
- Front Areas
 - Showroom – 40 cm height moisture average
 - Foyer and hall to warehouse – 25 cm height moisture average
 - Archive room – 35 cm height moisture average
 - Two office bathrooms – 30 cm height moisture average
- Back Areas
 - Electrical room – 30 cm height moisture average
 - Breakroom – 35 cm height moisture average
 - Two large bathrooms – 55 cm height moisture average
 - Washroom (where loss occurred) – 65 cm height moisture average and 140 cm high at loss point

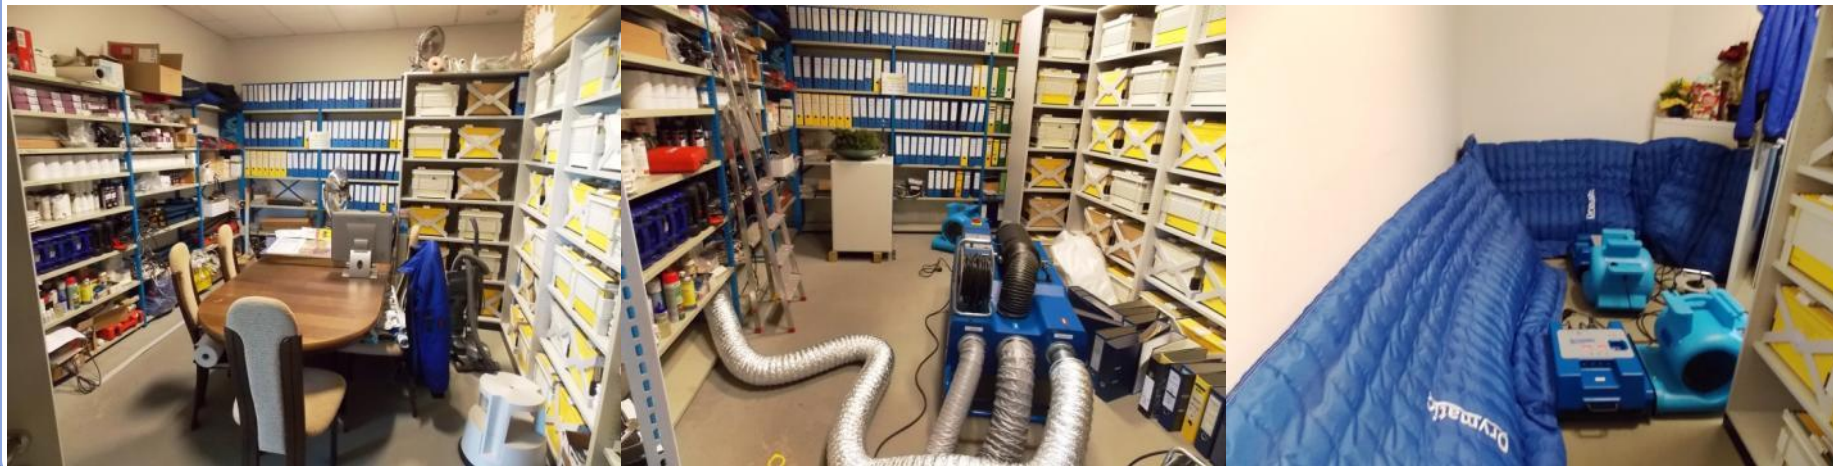
The Project – Archive/File room

- Consisted of a large area with walls connecting to showroom, hall, bathrooms and washroom with screed floor and plaster walls
- 1 Drymatic's, 2 boost boxes, 2 air movers and 2 wall mats were used for the total drying process of this area
- This was conducted during both phases and we could only take the temperature up to 30 due to the company server located in this room
- We had to work around the contents in this room and move them from side to side
- We used a sandwich drying approach drying from both sides of the walls

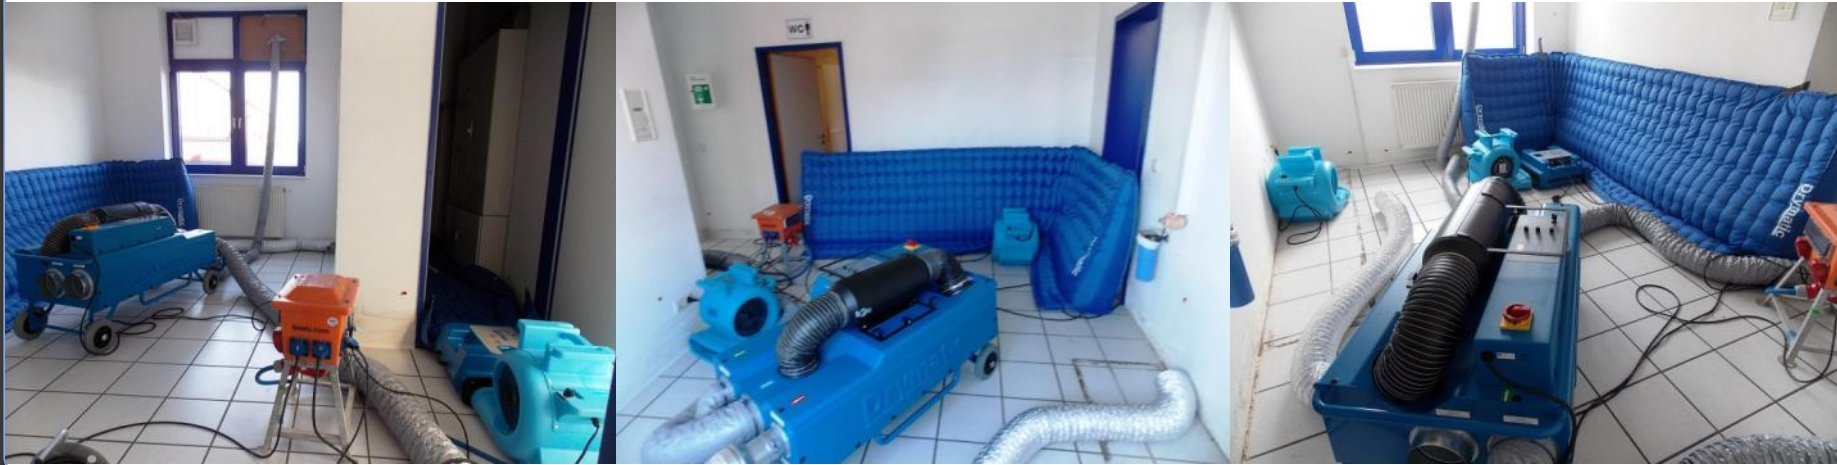
The Project – Break room

- Consisted of a large area with walls connecting to electrical, bathrooms and washroom with tile floor laid over screed and plaster walls
- 1 Drymatic's, 2 boost boxes, 2 air movers, 1 wall mat and 1 floor mat were used for the total drying process of this area
- This was conducted during the first phase and the contents were removed by the company
- We used a sandwich drying approach drying from both sides of the walls

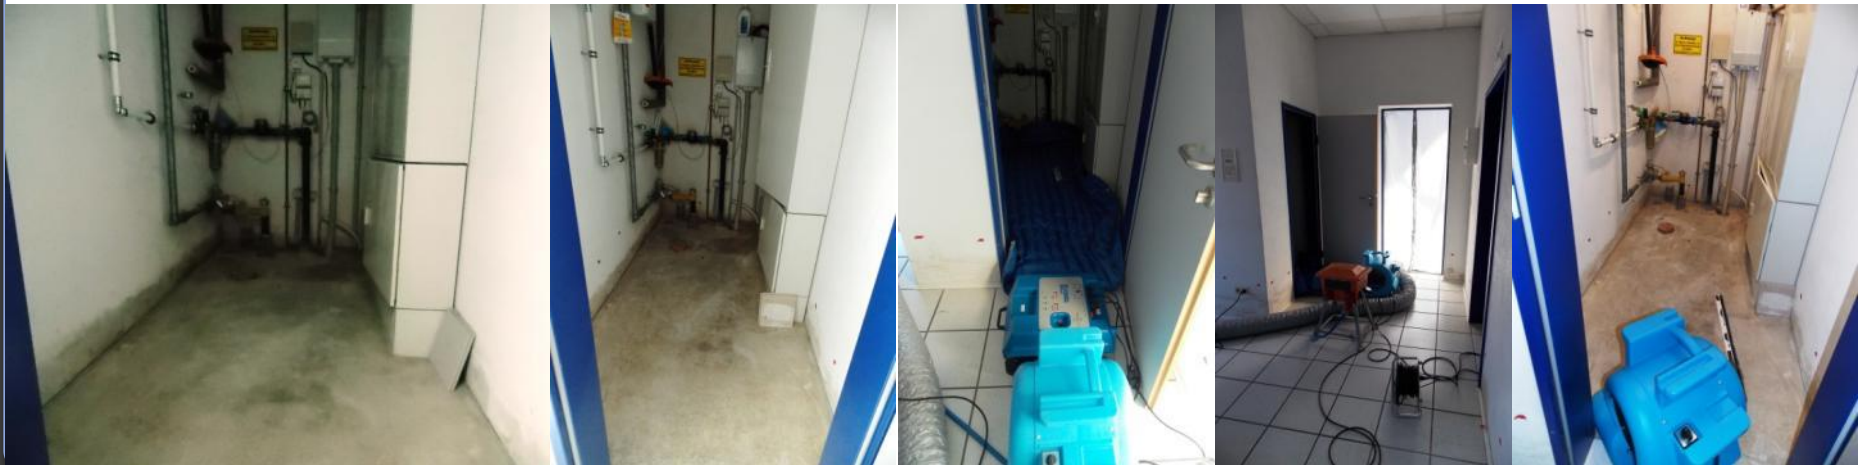
The Project – Electrical room

- Consisted of a small room with walls connecting to the break room and warehouse and consisted of a concrete screed floor and plaster walls
- 1 boost box, 1 air mover, and 1 floor mat were used for the total drying process of this area – 1 Drymatic was setup in the break room
- This was conducted during the first phase
- We used a sandwich drying approach drying from both sides of the walls

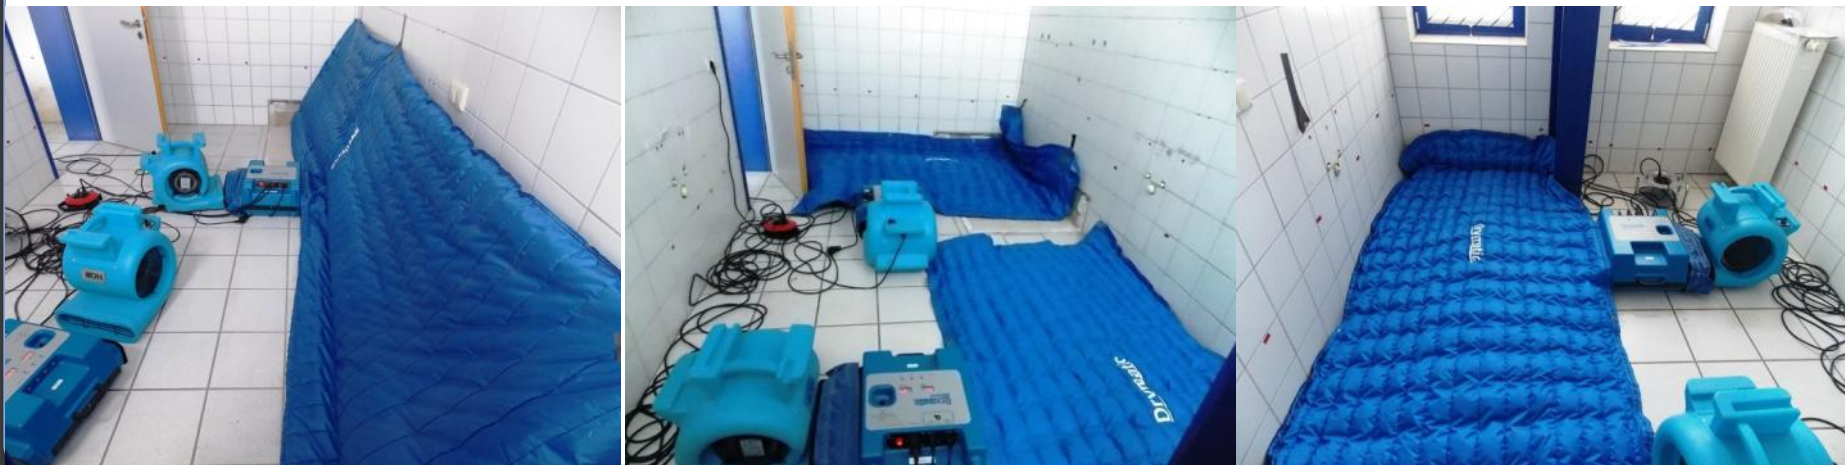
The Project – Washroom

- Consisted of a large area with walls connecting to the showroom, archive/file, and break room with tile floor laid over concrete screed floor and tiled walls
- 2 boost boxes, 2 air movers, 1 wall mat and 2 floor mat were used for the total drying process of this area – 1 Drymatic was setup in the break room
- This was conducted during the first phase and the contents, sinks, and shower pans were removed by the company
- We used a sandwich drying approach drying from both sides of the walls

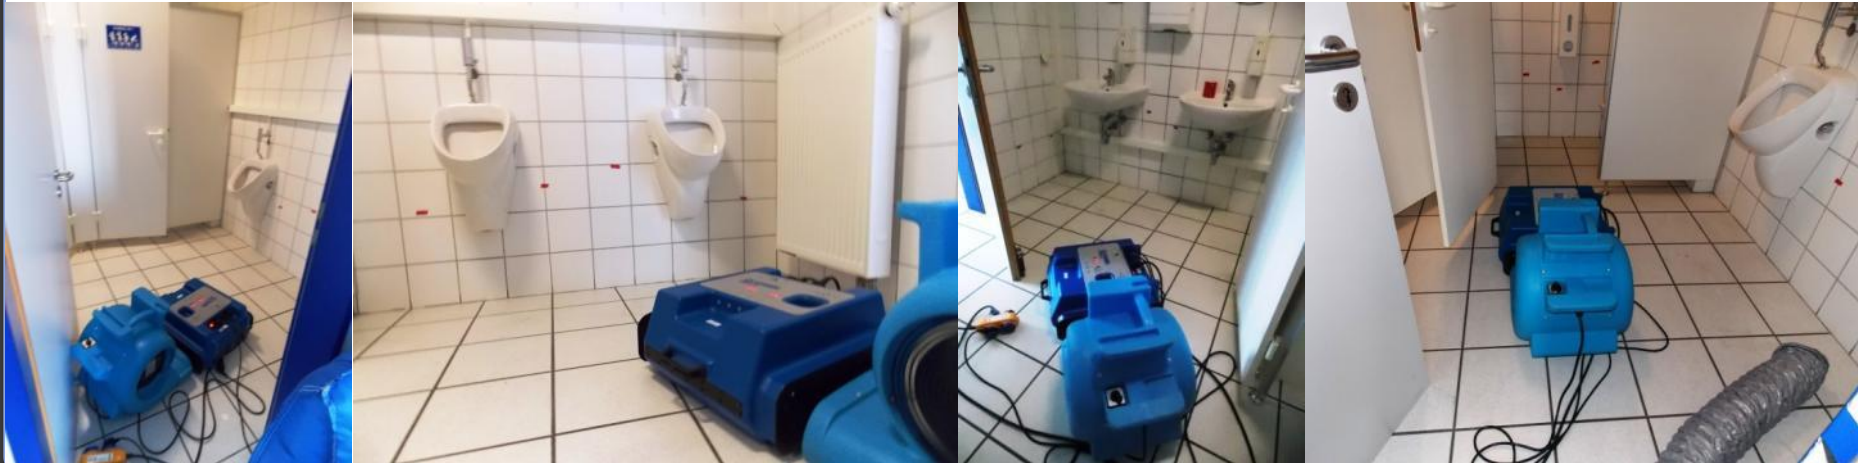
The Project – Bathrooms

- Consisted of a large area with walls connecting to the warehouse, hallway bathrooms, archive/file, and break room with tile floor laid over concrete screed floor and tiled walls
- 2 boost boxes, 2 air movers, 1 wall mat and 1 floor mat were used for the total drying process of this area – 1 Drymatic was setup in the break room
- This was conducted during the first phase and was being used daily by the companies employees
- We used a sandwich drying approach drying from both sides of the walls
