# Case Study

“Water Damage Grundschule Rülzheim”

# The Project

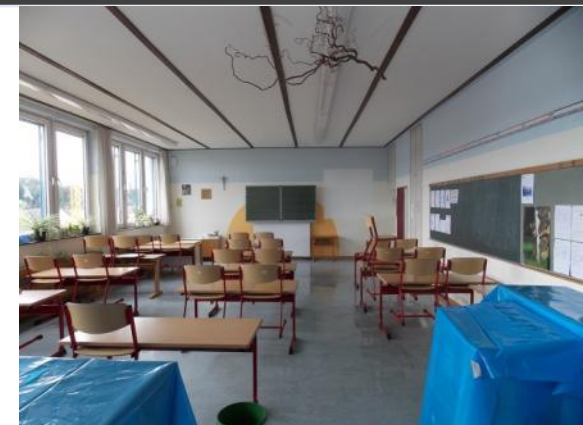
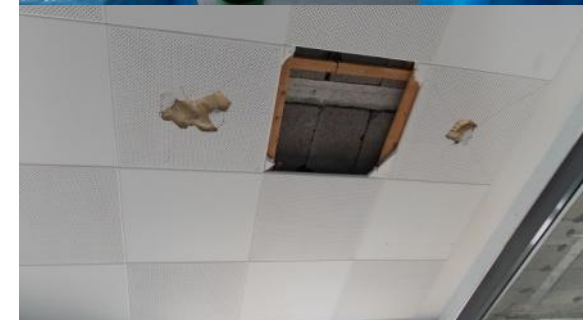
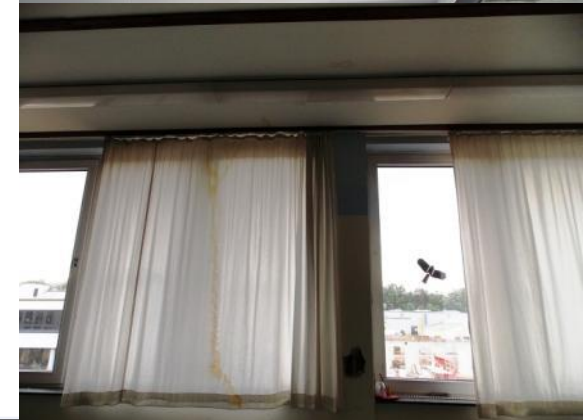
- Roofing was a pitched roof with wood framed construction and metal roof coverings and a concrete deck
- Temporary roofing was a flat roof with asphalt roof coverings laid over plywood which was laid on the concrete deck
- Flooring throughout was concrete based with a welded linoleum surface
- Walls were block construction with plaster covering
- Ceilings were a block construction with gypsum/plasterboard in hallways and classrooms and acoustic tiles with insulation in the stairwell's

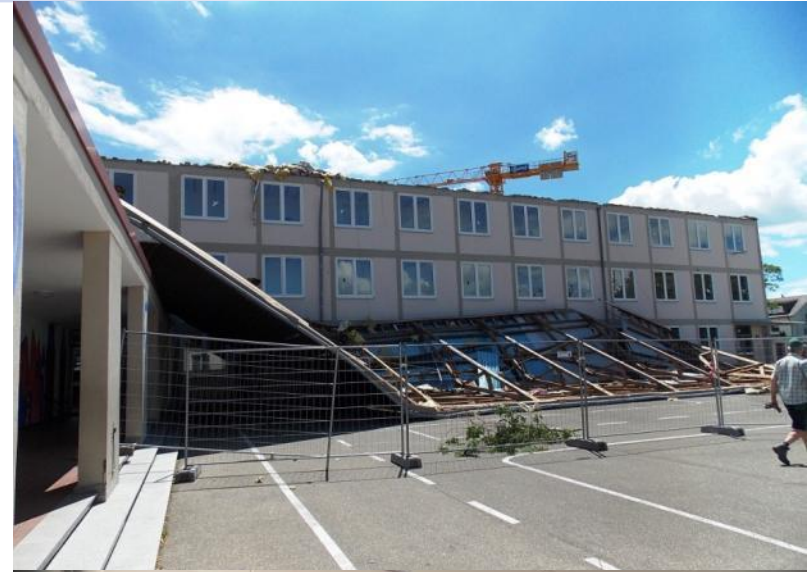
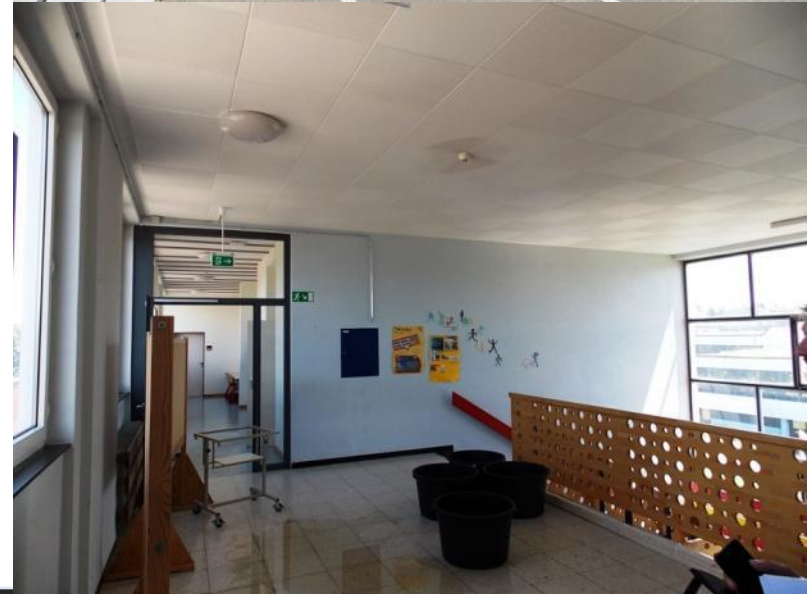
- The initial survey of the damage was the morning following the tornado on June 21<sup>st</sup> 2013
- Two other surveys and contractor meeting were conducted on June 21<sup>st</sup> and July 15<sup>th</sup> 2013
- Two people were needed to complete all surveys and each lasted about 2.5 hours to complete
- Equipment used to measure moisture
  - FLIR B20HSV Infrared Camera
  - Fluke TiR32 Infrared Camera
  - Tramex Moisture Encounter Plus moisture meter
  - Tramex Concrete Encounter CME4 moisture meter
  - Tramex MRH 3 moisture and humidity measurement meter
  - Tramex RWS Roof and Wall Scanner deep penetrating measurement meter
- This equipment was used during the complete drying process and for drying verification

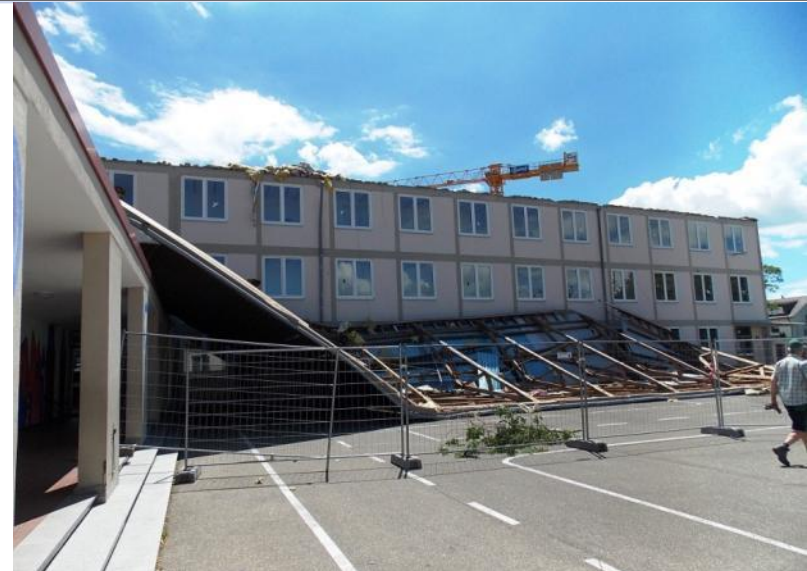
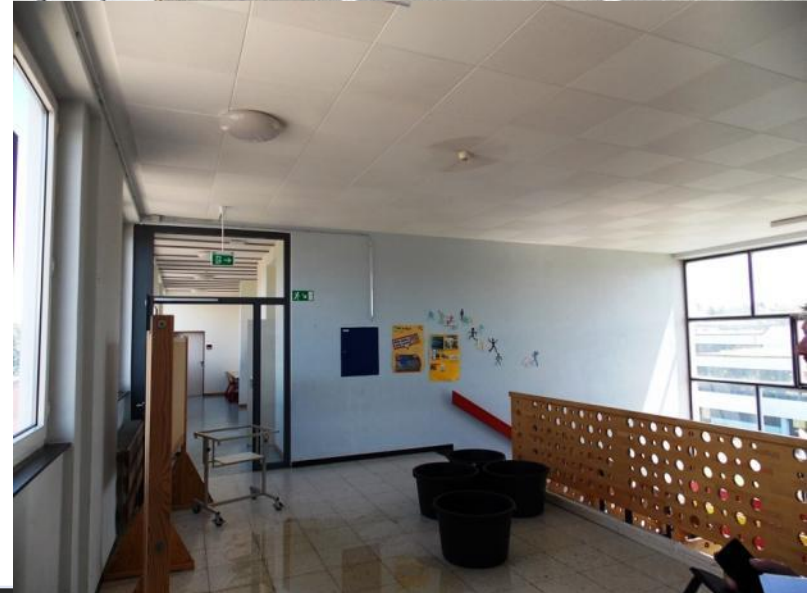
- The initial survey of the damage was the morning following the tornado on June 21<sup>st</sup> 2013
- Two other surveys and contractor meeting were conducted on June 21<sup>st</sup> and July 15<sup>th</sup> 2013
- Two people were needed to complete all surveys and each lasted about 2.5 hours to complete
- Equipment used to measure moisture
  - FLIR B20HSV Infrared Camera
  - Fluke TiR32 Infrared Camera
  - Tramex Moisture Encounter Plus moisture meter
  - Tramex Concrete Encounter CME4 moisture meter
  - Tramex MRH 3 moisture and humidity measurement meter
  - Tramex RWS Roof and Wall Scanner deep penetrating measurement meter
- This equipment was used during the complete drying process and for drying verification
