Case Study

“Water Damage SERR ROLF SR Metallbau
Rülzheim”

The Project

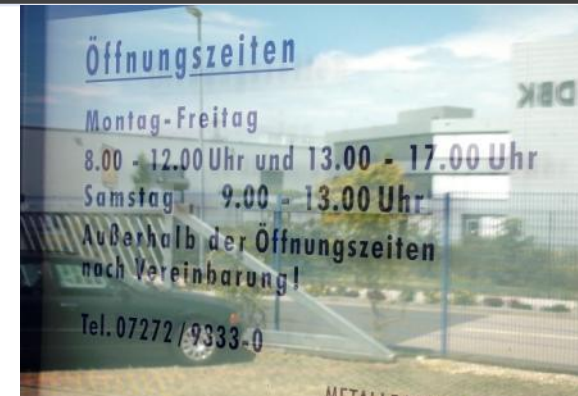
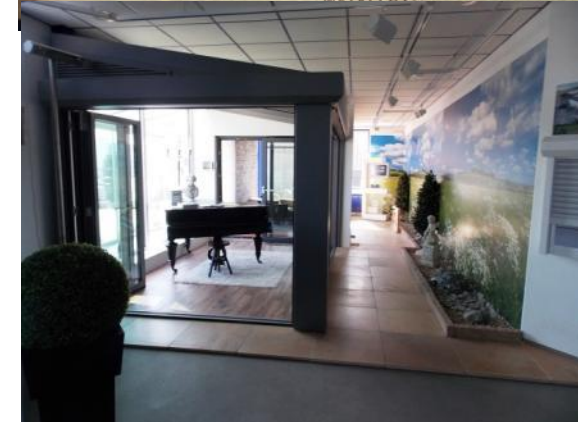
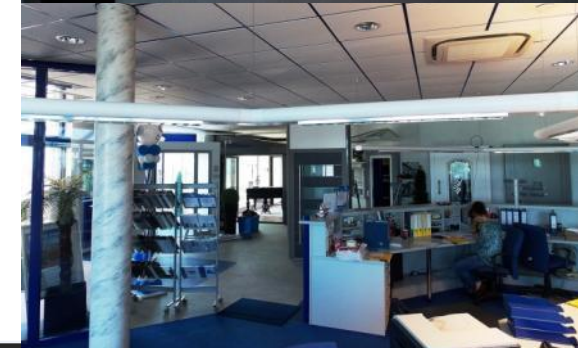
- Water Damage to SR Metallbau in Rülzheim
- DBK Germany is also located directly across the street in Rülzheim
- 210 M² total area of drying
- Commercial enterprise that needed to continue business operations
- No insurance coverage for this water loss
- Bid was awarded to DBK Germany on June 5th 2013 due to the new Drymatic heat drying system
- One other German Water Damage contractors also bid on the job using the traditional drying technology used in the German market and needing 28+ days to complete each area
- The other contractor was going to ruin the floor in the office and showroom, flooring and wall tiles in the back areas by drilling holes to complete the drying process

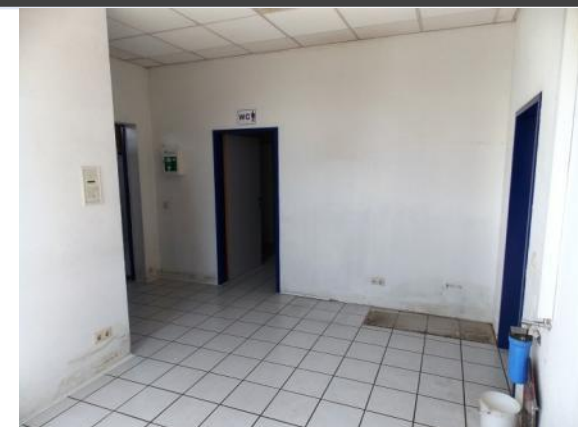
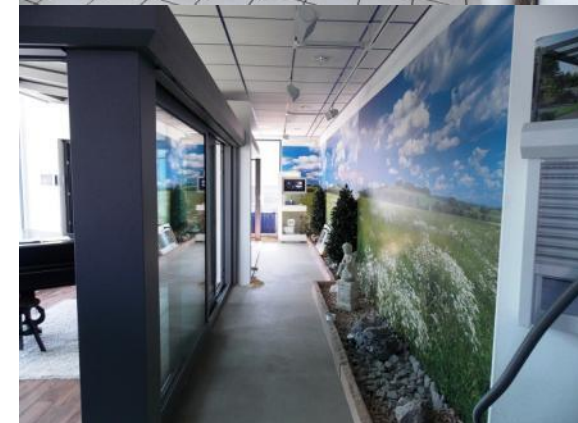
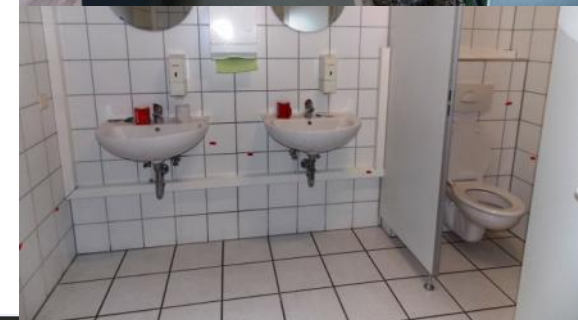
The Initial Survey - Construction

- Flooring throughout was concrete/screed based standard German construction of 5 cm screed, 8 cm of Styrofoam on a bituthene membrane laid over concrete
- Finished flooring materials consisted of sealed concrete screed in the front areas and tile in the bathroom and back areas
- Walls were block construction with plaster covering and wallpaper in the front areas and tile in the bathrooms and wash room areas
- Ceilings were a concrete deck with a dropped acoustic ceiling tiles

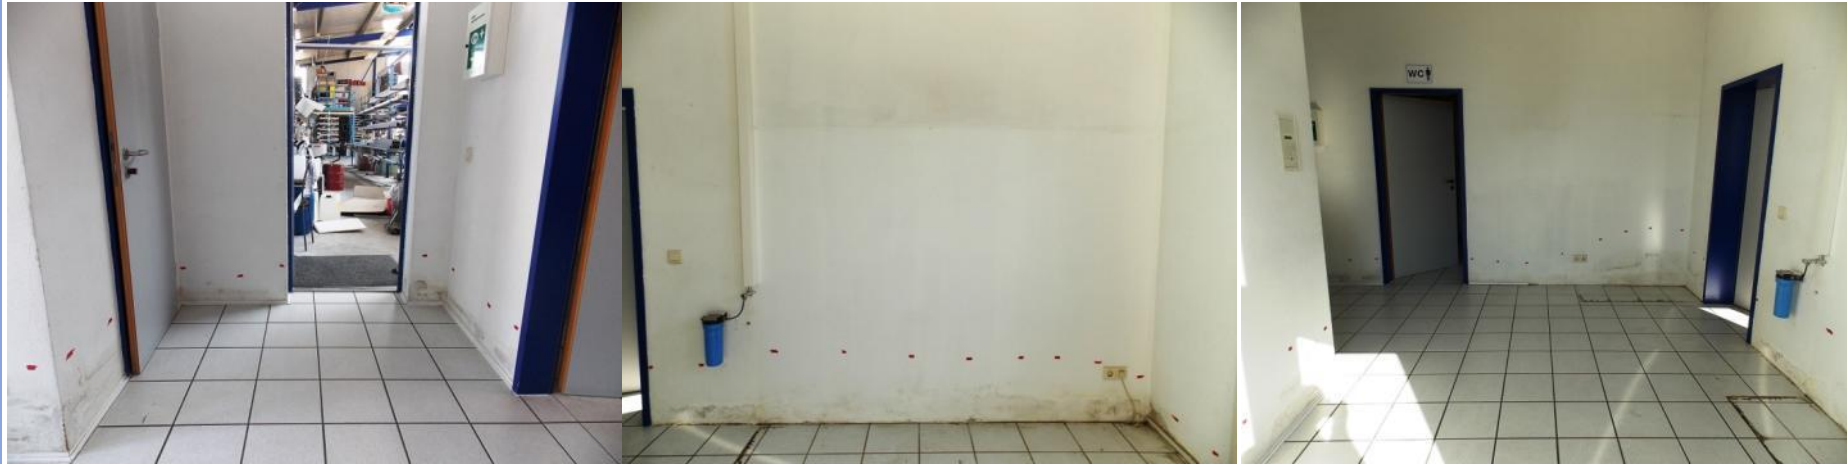
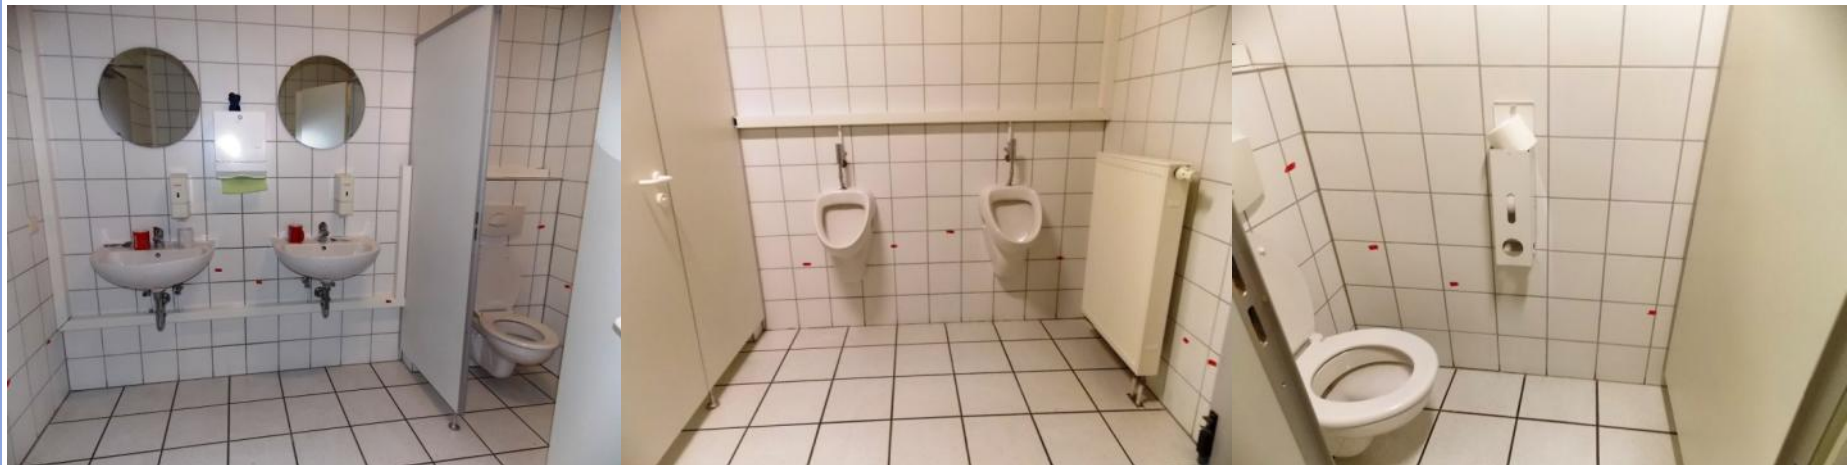
The Initial Survey – Moisture Mapping

- Front Areas
 - Showroom – 40 cm height moisture average
 - Foyer and hall to warehouse – 25 cm height moisture average
 - Archive room – 35 cm height moisture average
 - Two office bathrooms – 30 cm height moisture average
- Back Areas
 - Electrical room – 30 cm height moisture average
 - Breakroom – 35 cm height moisture average
 - Two large bathrooms – 55 cm height moisture average
 - Washroom (where loss occurred) – 65 cm height moisture average and 140 cm high at loss point

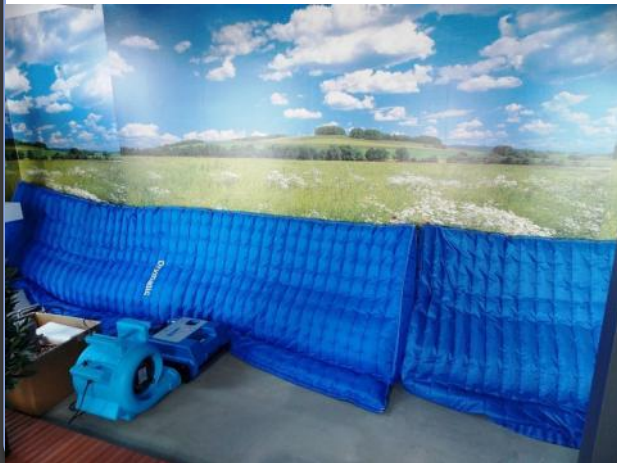
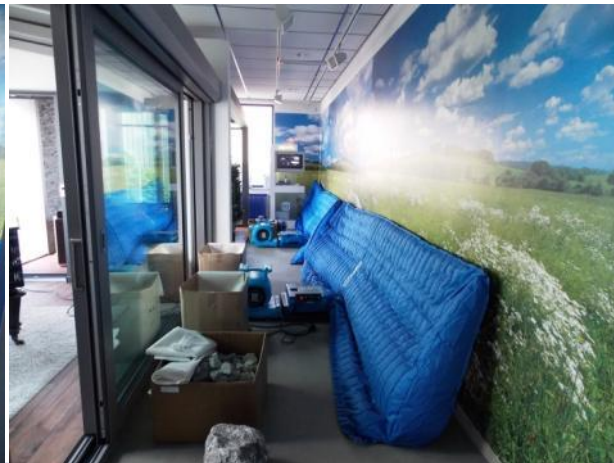
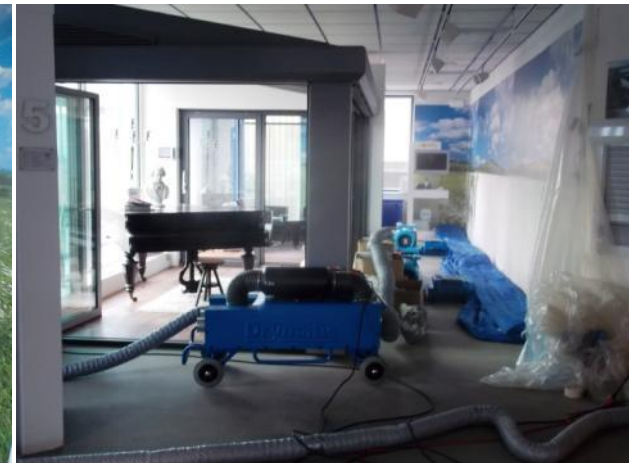
The Project – Showroom

- Consisted of a very large area with sections for display's, entry, office, bathrooms and hallway with screed flooring and plaster walls
- The plastic film wall paper was removed ½ halfway for drying and all contents were removed by the company
- 1 Drymatic's, 2 boost boxes, 2 air movers and 2 wall mats were used for the total drying process of these areas
- This was conducted on the second phase and we could only run the equipment at night and on the weekends
- We used a sandwich drying approach drying from both sides of the walls

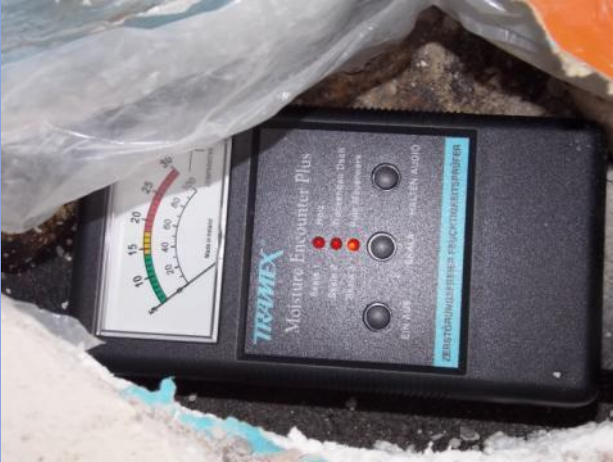
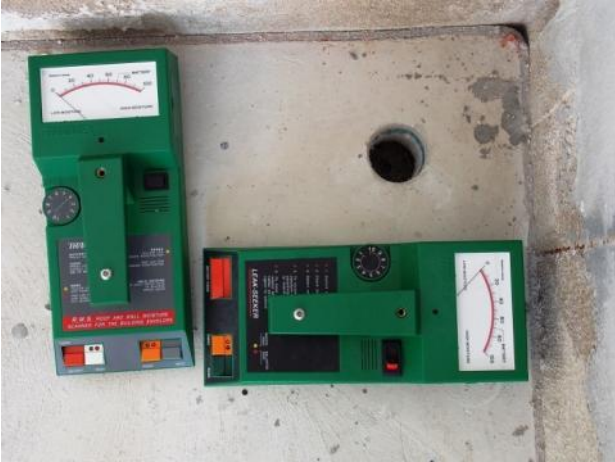
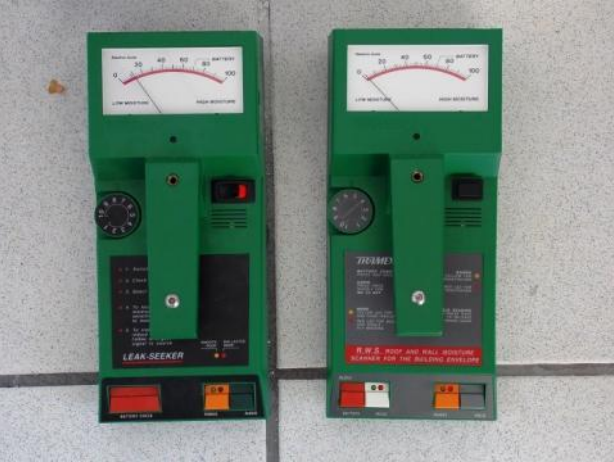
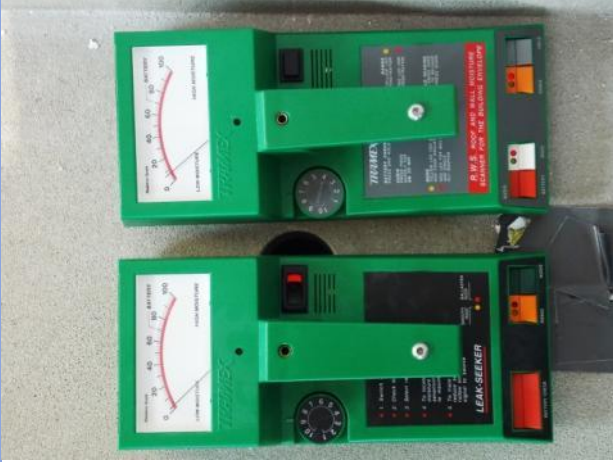
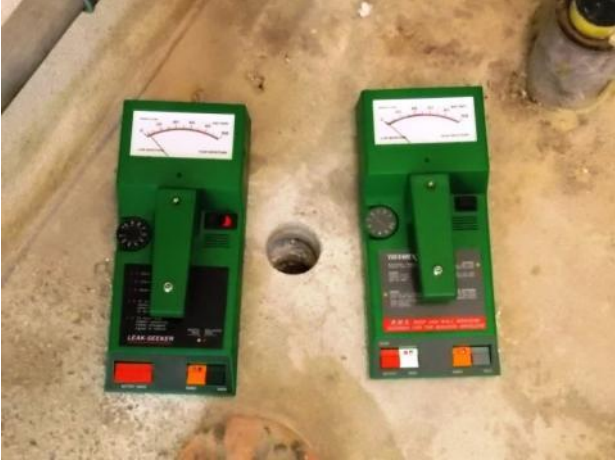
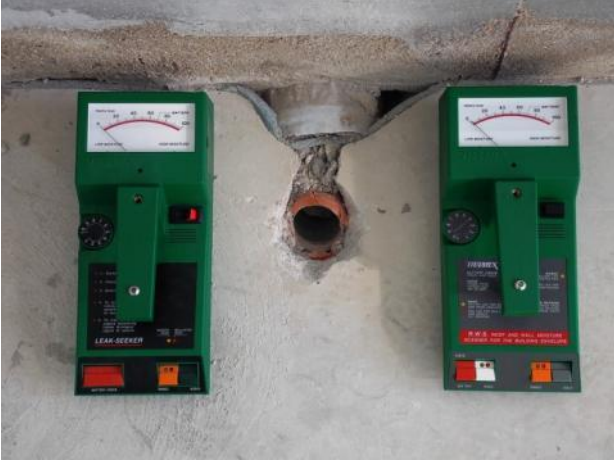
The Final Survey - Floor

- Drying of these areas was verified using the moisture detection equipment, as well as conducting complete and detailed moisture mapping of these areas from prior to the start of the job, during the progress of the drying phase and at completion prior to removal of the drying equipment.
